The Lack of Safety Facilities on Pintu Angin Biak Road Results in Less Users Negating Driving Safety

Abstract

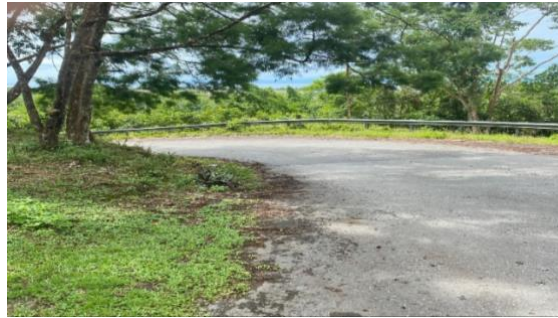
Figure 3. (a) this road has the potential for conflict (Hazard)

The condition of the road is uphill and turns with the geometry of the road that is not in accordance with the standard where the slope is quite high and the bend radius is large enough (>50). Then it is not supported by incomplete signs and markings added with hazards so that the vehicle has difficulty seeing the vehicle from the opposite direction. that does not exist so that the road is considered unsafe.

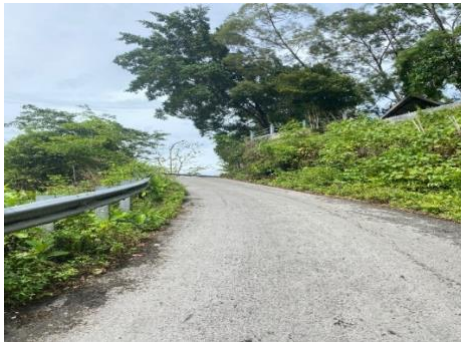
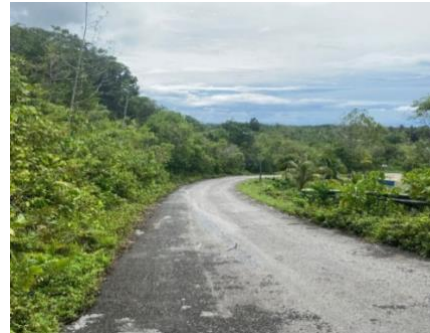
Figure 3 (b). The road is not equipped with signs, markings, and street lighting

In the picture, it is shown that the road does not have markings, and the conditions for installation are, the white road markings mentioned in paragraph (1) letter a indicate that road users must comply with orders or prohibitions in accordance with the form of the markings[12].

The road is not equipped with public street lighting. Therefore, the following is a guide for the placement and installation of street lighting equipment as stipulated in Article 6 paragraph (1) letter b, which is carried out on:

1. Placement of traffic signs in the form of warning signs going down the mountain or going up an uphill. The installation of signs as in the picture above provides a warning for drivers about changes in road conditions. The placement of warning signs is placed 250 meters before the critical location.

2. Street lighting.
The installation of street lighting is very functional for motorists to be able to see the road properly, in addition, it can reduce the incidence of accidents and to prevent crimes, such as begal and other crimes.
The placement and installation of street lighting lights is carried out on: b. Road network, which includes: 1. Toll Road; 2. Main road (artery); 3. Connecting roads (collectors); 4. Local roads; and 5. Roads in residential areas (neighborhoods).
At this location, the installation and placement of street lighting lights is about 45 meters away, with a pole height of 7 meters, and a lighting level of 10 – 20 lux.

5. Road Markings
Road markings function as lane separators on the road so that vehicles in the opposite direction do not pass through other users' lanes. White road markings indicate that road users must comply with the orders or prohibitions set according to the form of the markings.

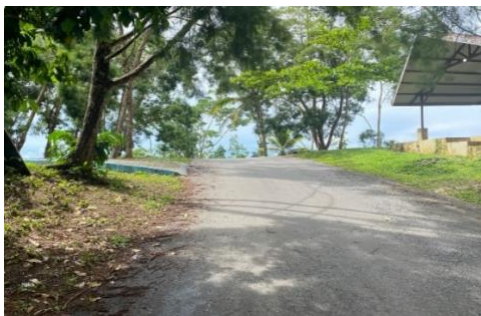
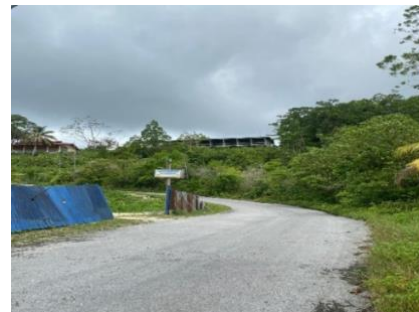
Figure 3 (c). Turning ramps and blindspots

Placement of convex glass serves as an enhancer This convex glass is usually installed on the side of the road in areas where the visibility of motor vehicle drivers is very limited, especially in sharp corners or intersections (Director General Contact Darat, 2011).

4. Installation of convex glass so that the driver can see the vehicle from the opposite direction.
This convex glass is very functional to be installed on turning roads, as well as on roads that are prone to accidents, so that vehicles from the front can see other vehicles from the opposite direction. The installation and placement of this convex glass is placed on the side of the road.
